## Analysis of Road Traffic Accidents on NH 45 (Kanchipuram District)

### ABSTRACT

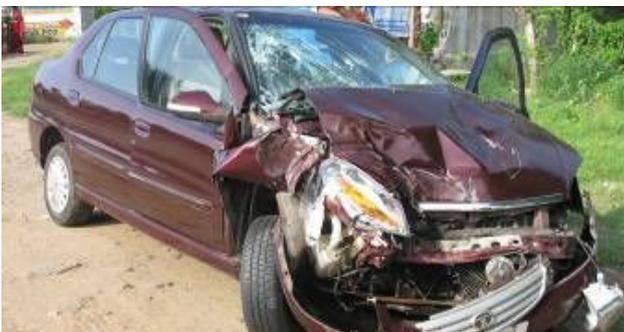
Figure 2: Frontal impact damage

Based on the type of vehicle involved, researchers scientifically describe impacts on a vehicle by using the seven-character Collision Deformation Classification (CDC) code as per the Society of Automotive Engineers (SAE) standard J224 [1] or the seven-character Truck Deformation Classification (TDC) code as per the Society of Automotive Engineers (SAE) standard J1301 [2]. This internationally accepted standard crosses language barriers and gives a 3-dimensional description and specified magnitude of the impact damage on a vehicle. In addition the CDC/TDC helps in describing, recording and communicating vehicle impact damage very easily in reports and analyses. CDC/TDC retains the damage information for reference should it be required at a future date, especially in the physical absence of the vehicle. An example of CDC is described using the damaged car, shown in figure 2, examined in our study.

For the impact damage shown in figure 2, the CDC obtained is:

**0 1 F Z E W 3**

01 = Principal Direction of Force (1 o'clock direction)

- F = Type of Impact (Frontal)
- Z = Location of Damage (Right and centre of frontal area)
- E = area)
- W = Vertical Location (Below lower end of windshield)
- 3 = Type of Damage Distribution (Wide)
- Maximum Extent of Crush from front bumper to lower windshield on a scale from 1 to 5

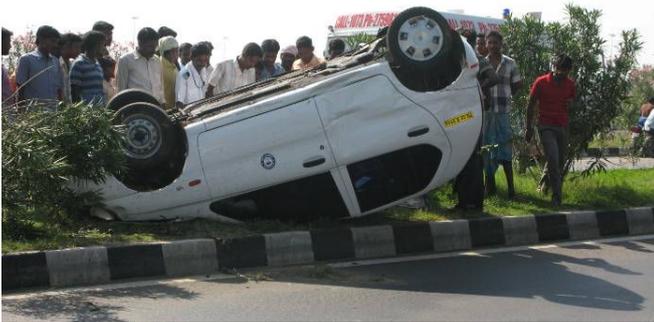
Figure 3A: Rollover accident.

An example of injury coding and correlation is described below. Figures 3A, 3B and 3C show the exterior and interior parts of a car involved in a rollover accident examined under this study. Although the driver escaped uninjured, the front left occupant sustained injuries in the accident.

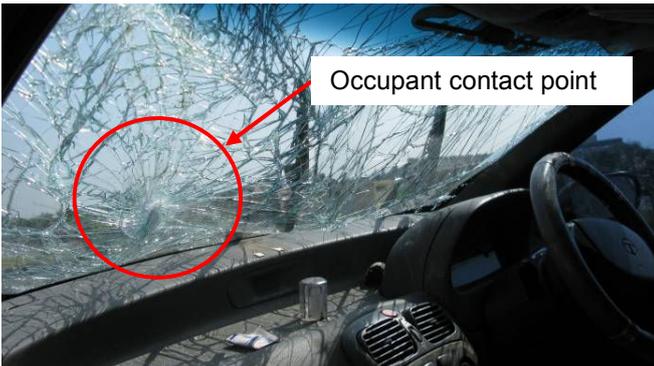
Figure 3B: Roof crush measured is 18 cm and occupant contact identified.

The occupant contact points in the car interiors, shown in figures 3B and 3C, were examined and then correlated with the injuries of the occupant to determine the cause of each injury. As can be seen the blood marks on the roof indicate injury on the head. On closer inspection of the windshield, blood marks were found giving the indication that the occupant's head hit the windshield, which caused the injury. Hence the source of the head laceration was determined as windshield.

This also indicates that the occupant was not wearing seatbelts, and the same was confirmed on checking the

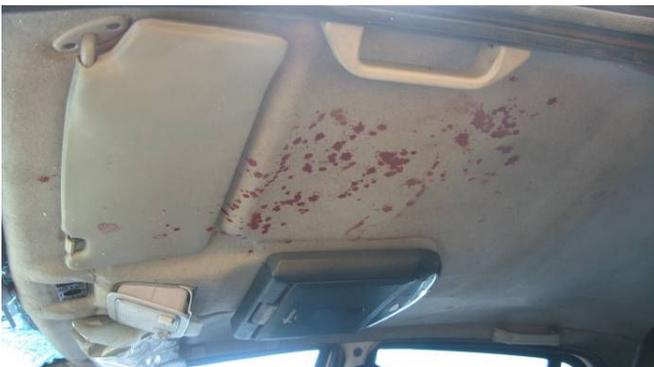
Figure 3C: Occupant contact points.
